**Flood Control, Mississippi River and Tributaries
Yazoo River Basin - Tallahatchie River
Tallahatchie County, Mississippi**

**Ascalmore Creek - Tippo Bayou
Item No. 3, Control Structure**

**FOUNDATION
REPORT**

January 1992

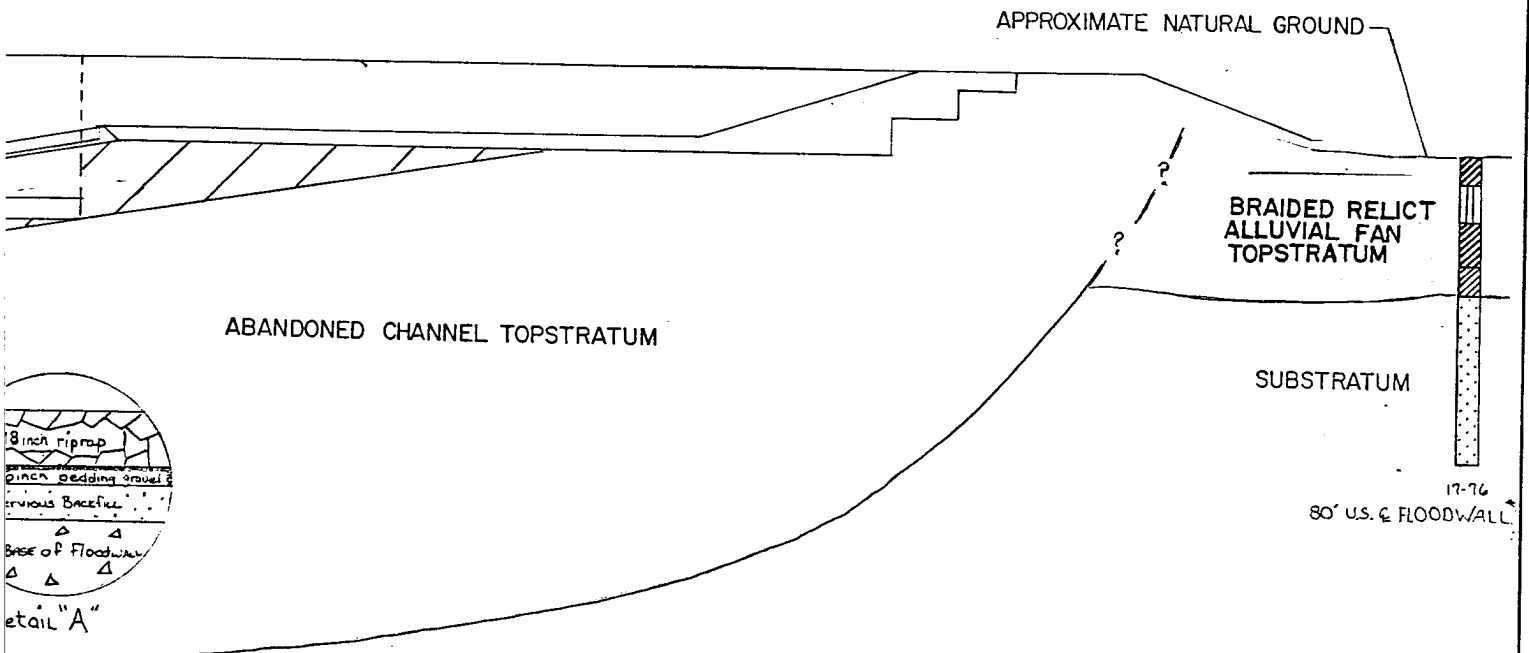
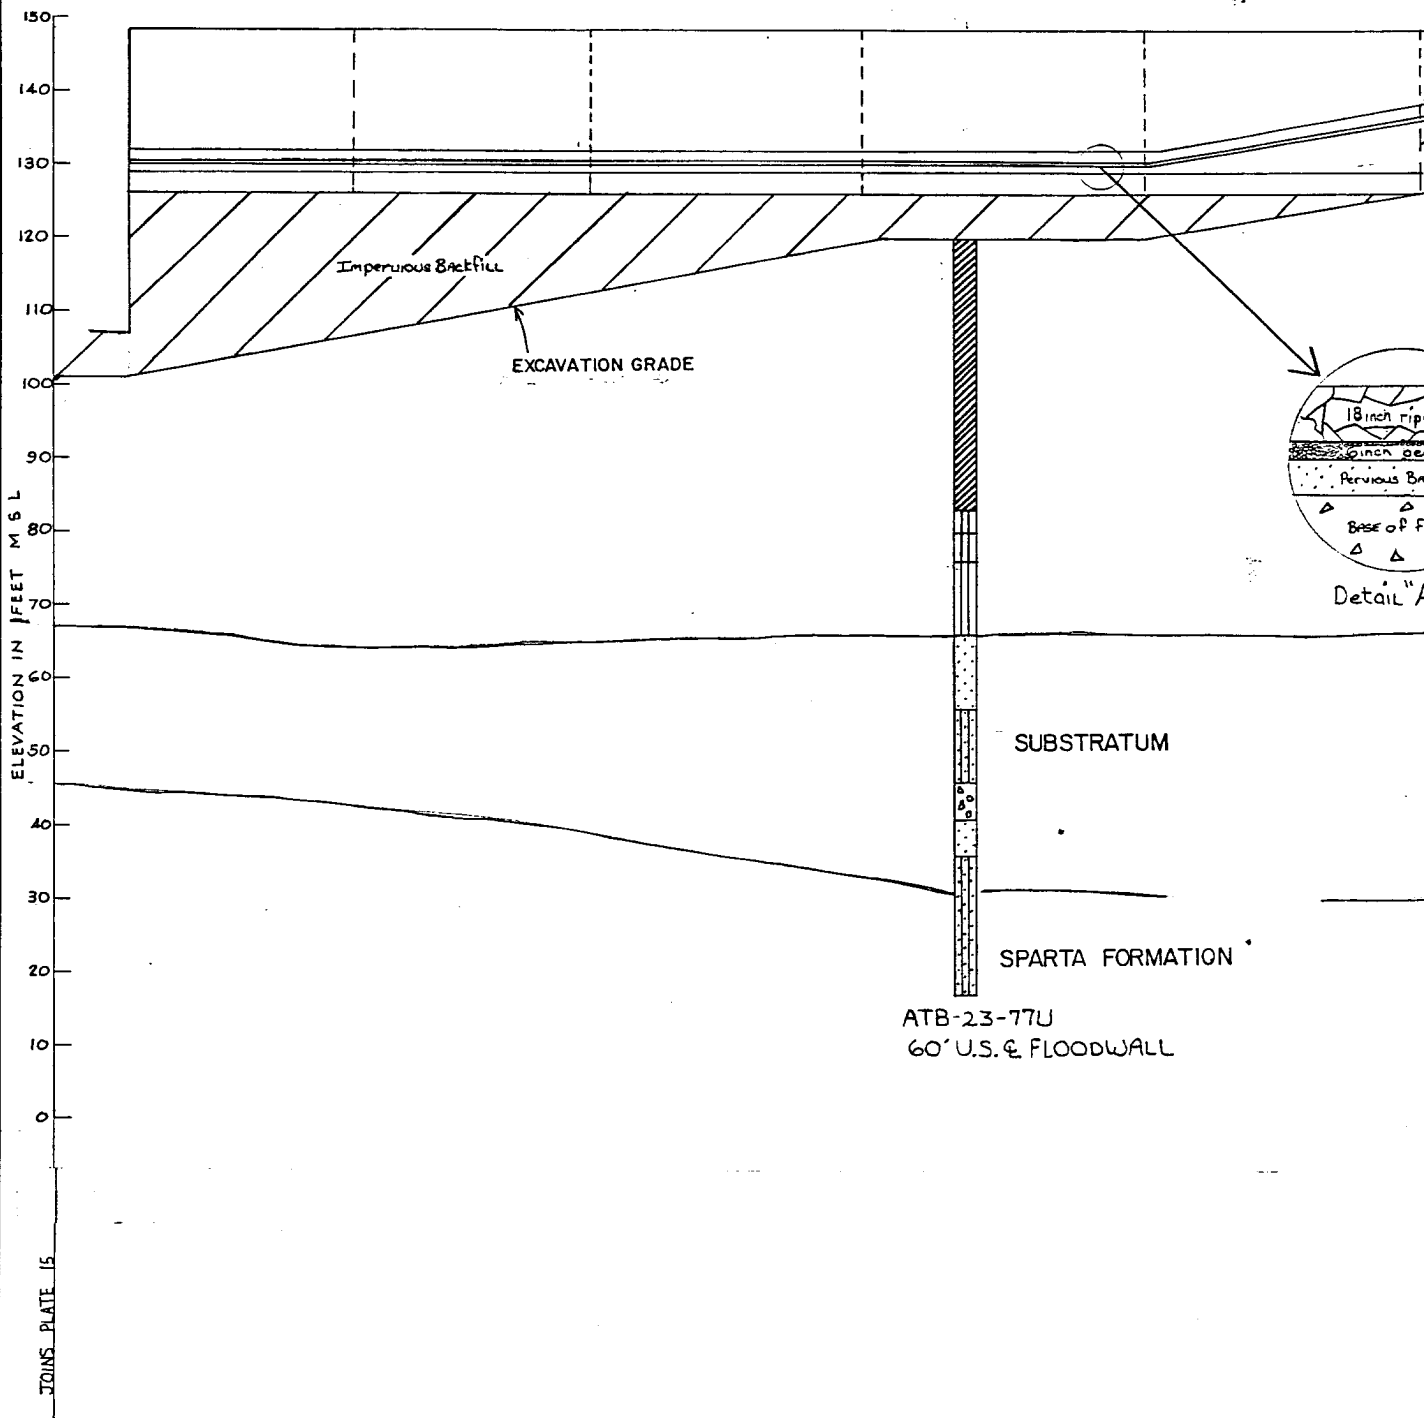
FOUNDATION REPORT	DATE: JAN 1992	FILE NO. YT-15-45	PLATE 15
-------------------	----------------	-------------------	----------

**GEOLOGIC PROFILE; S-FLOODWALL
B-B SHEET 2 OF 2**

g. Floodwalls. A north and south floodwall extends from the approach monolith and ties into natural earth. The outermost portion of the floodwall consists of an I-wall which extends to an elevation of 148.5 feet. Individual monoliths and foundation grades for the floodwall are shown on Plates 14 and 15.

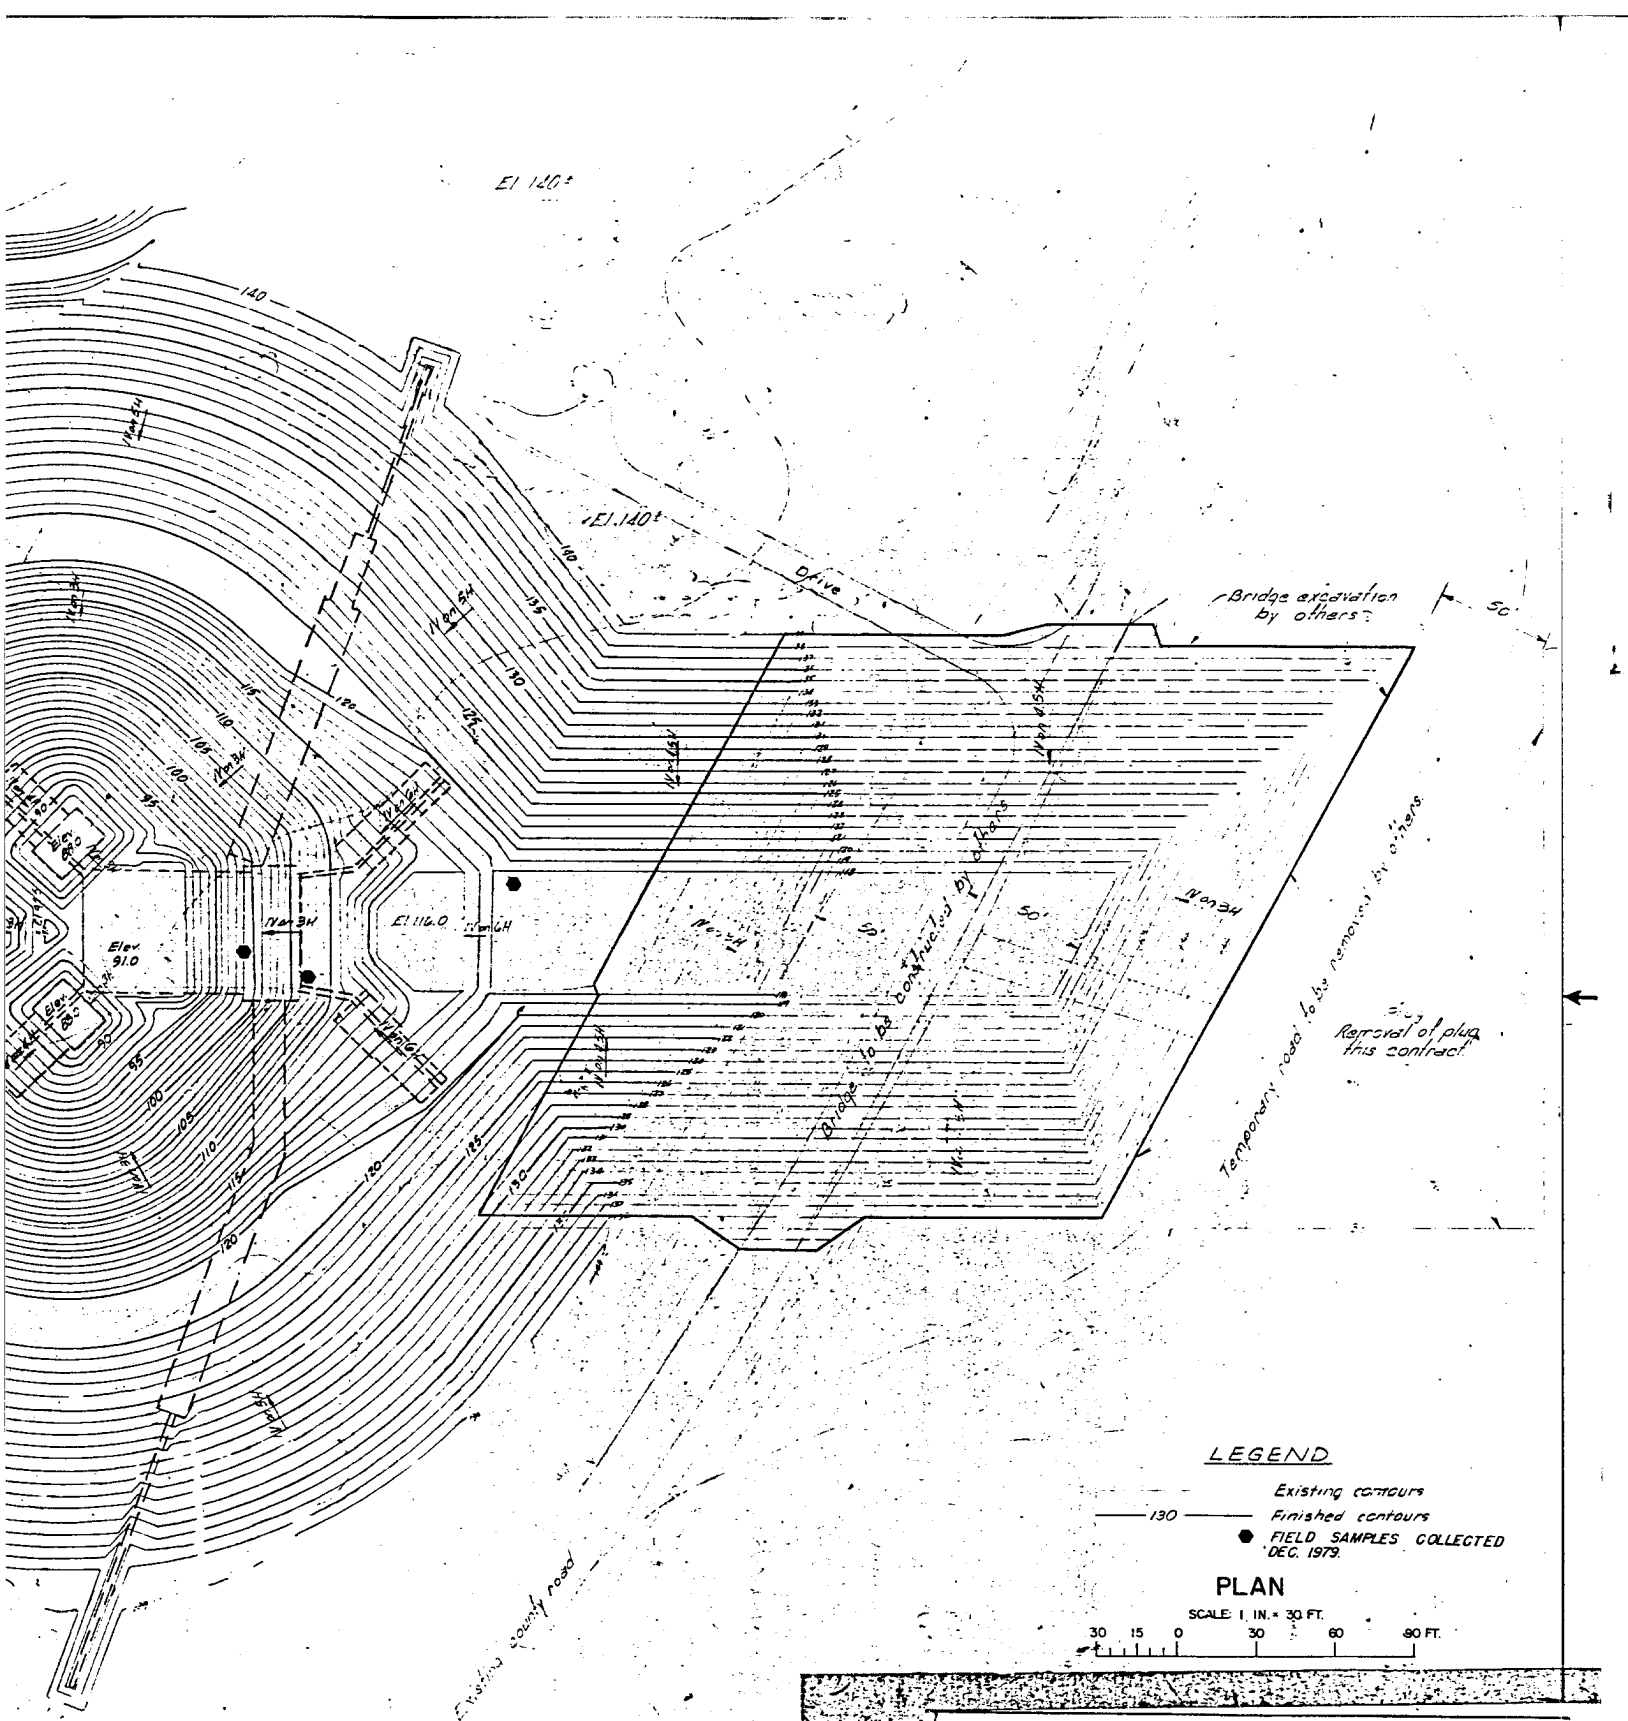
FOUNDATION REPORT	DATE: JAN 1992	FILE NO. YT-15-45	PLATE 17
-------------------	----------------	-------------------	----------

EXCAVATION PLAN

a. General. The Ascalmore-Tippo Control Structure consists of six basic components (Plates 11 and 17). The structure is approximately symmetrical and consists of riverside retaining walls (north and south), channel side retaining walls (north and south), an approach monolith, a gated/drop monolith, a stilling basin monolith, and a floodwall (north and south). The control structure was constructed on an H-pile foundation (see Section 7-04).

6-04. Foundation Materials Mapped. All soils mapping was done in accordance with the Unified Soil Classification System (USCS). Soil types were grouped together and assigned to their respective geologic units which are identified on Plates 11, 12, 13, 14, and 15. Excavation for the structure was entirely in abandoned channel "clay plug" material. A large part of the structure was constructed on backfill materials and all of the structural components were founded on H-piles. For these reasons no attempt was made to map the exposed foundation areas in plan view. However, samples of foundation materials were recovered. The location and laboratory classification of recovered samples is shown on Plate 17 and Table 1.

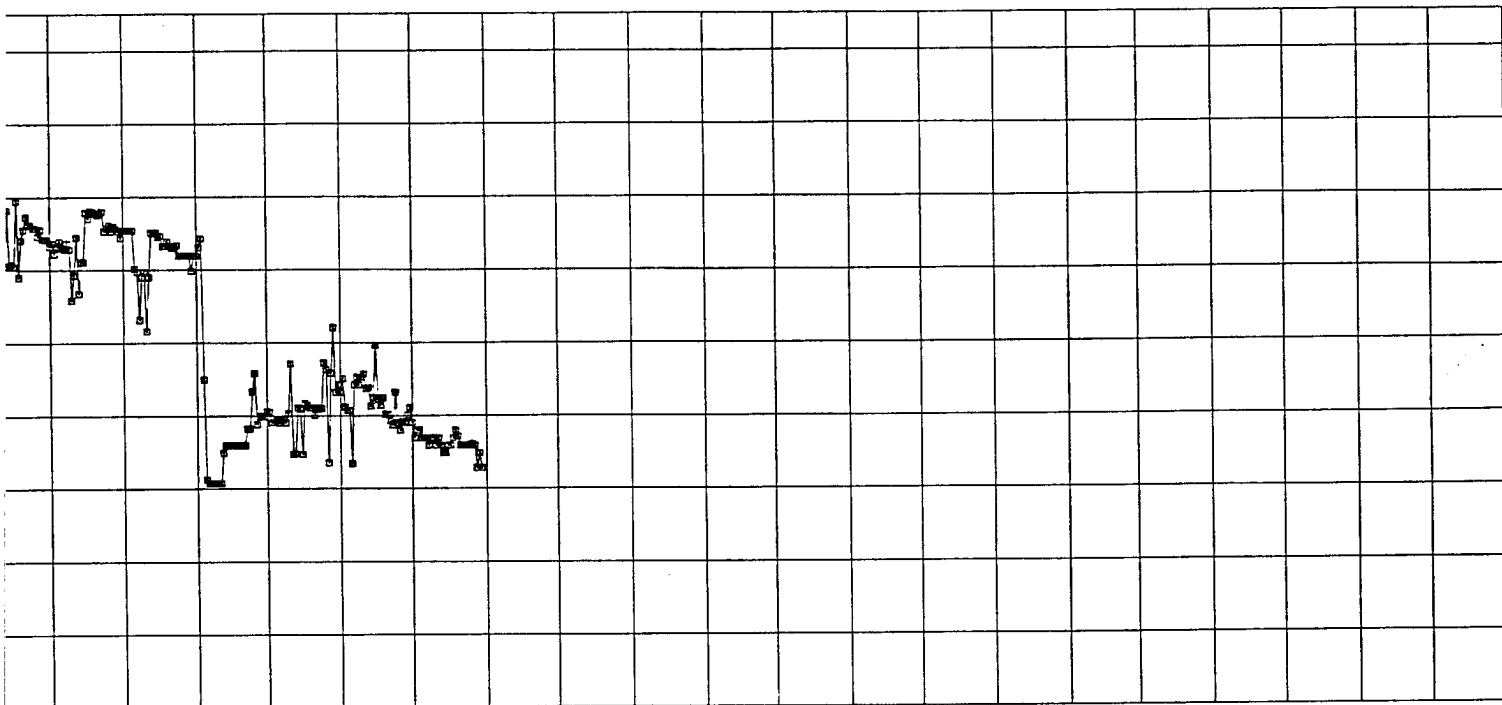
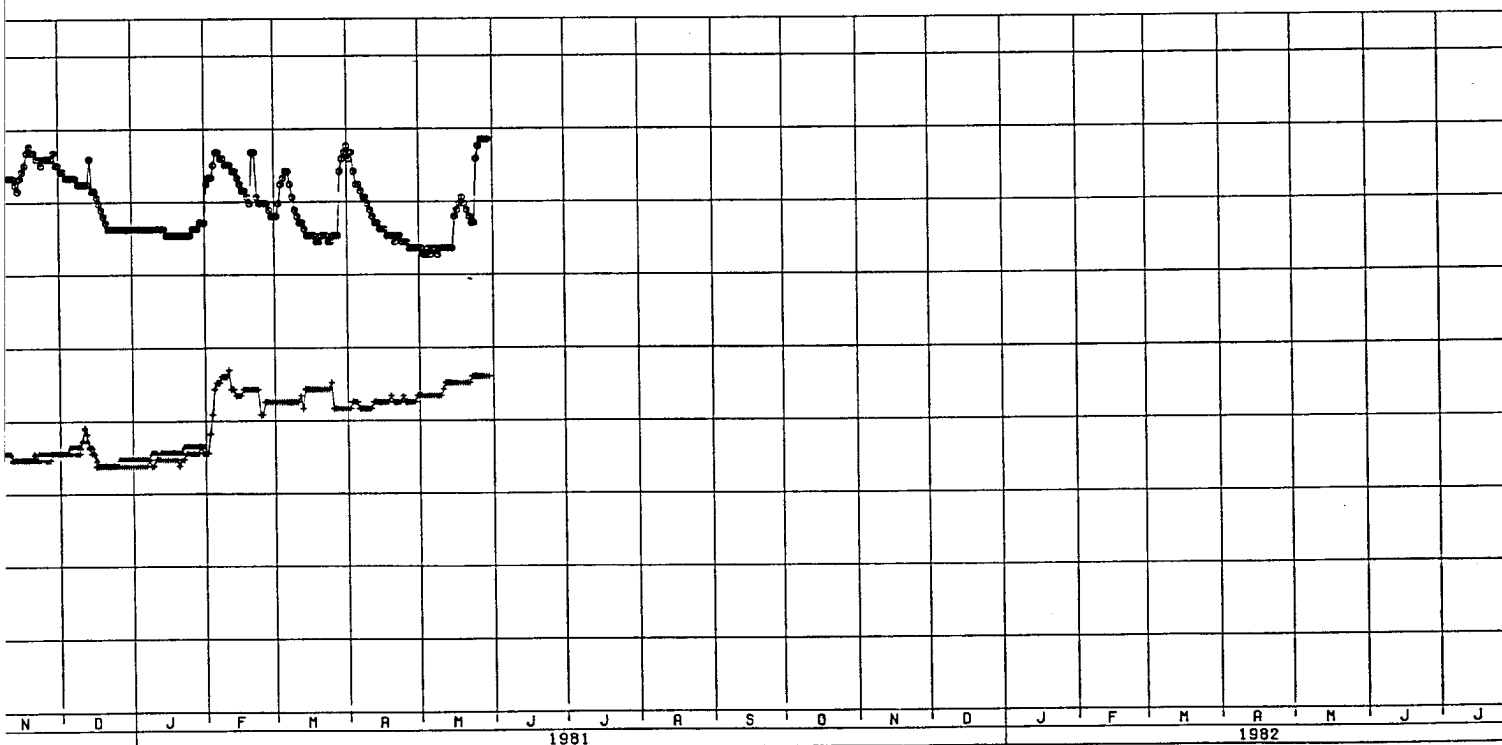
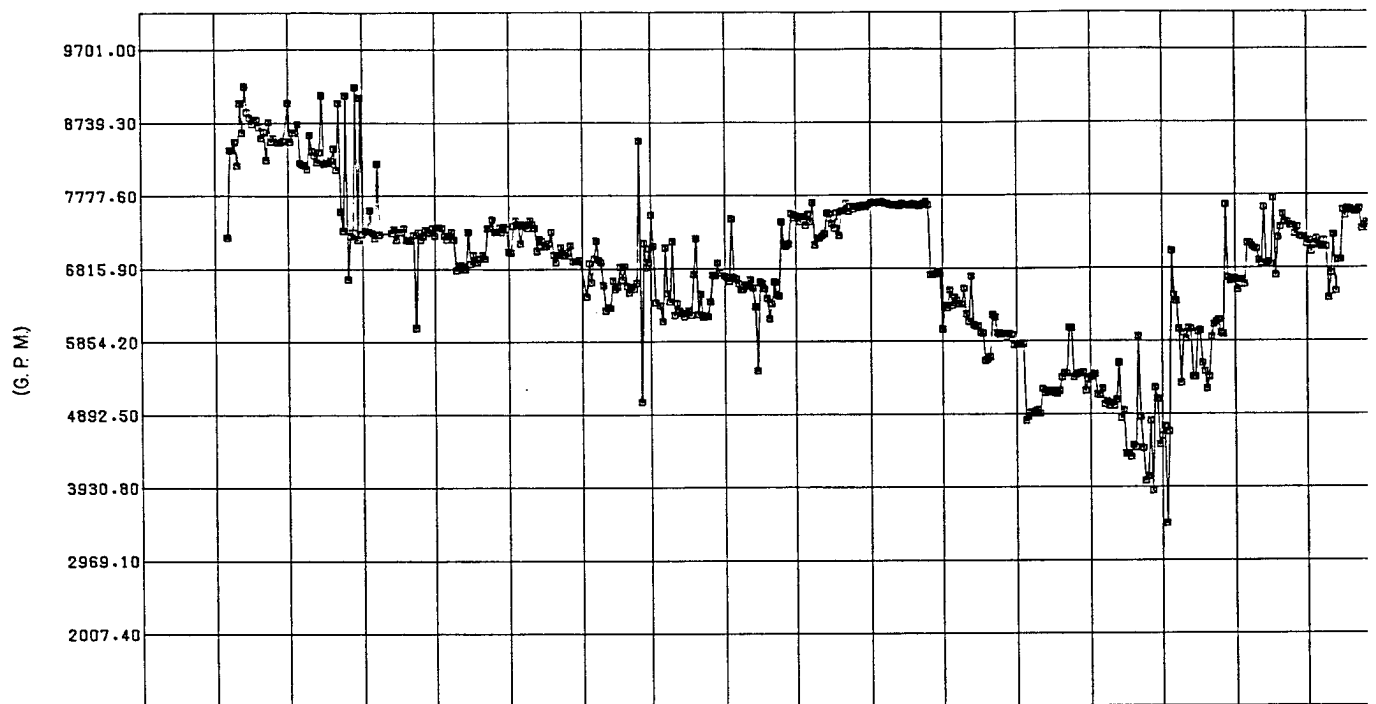
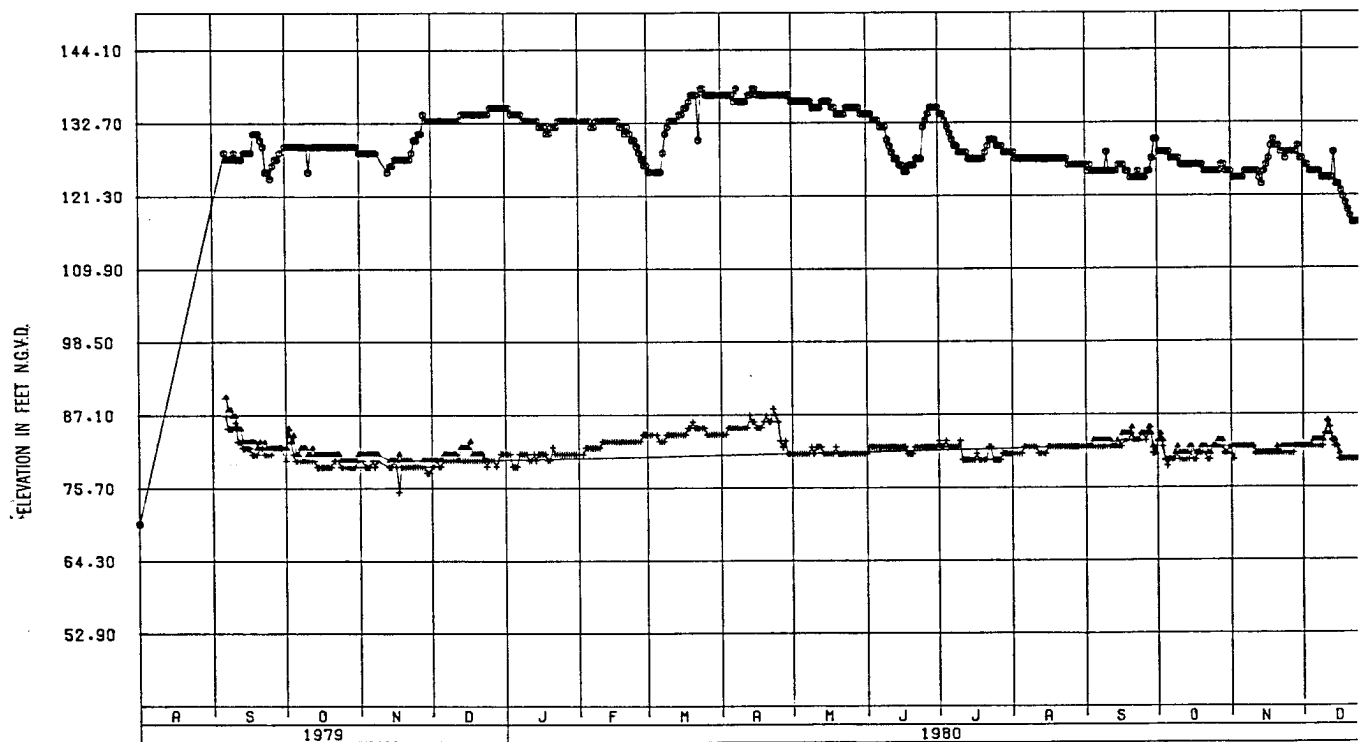
FOUNDATION REPORT DATE: JAN 1992 FILE NO. YT-15-45 PLATE 19

DEWATERING TOTALS

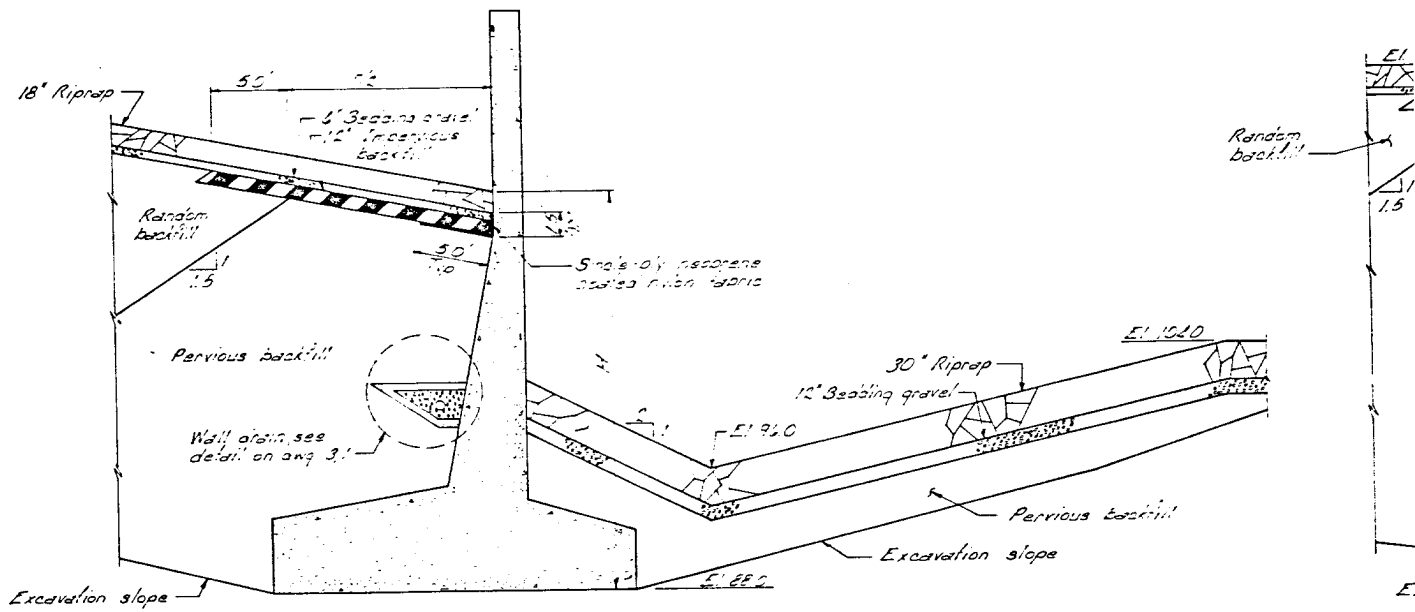
SECTION C-C

SCALE: 1 IN. = 5 FT.

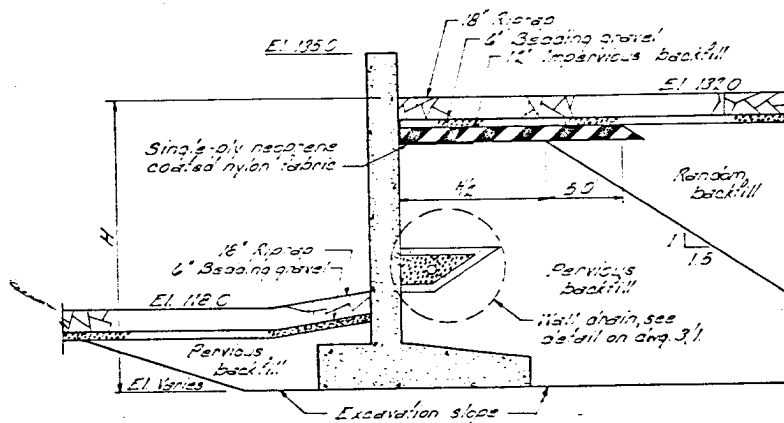
SECTION F-F

SCALE: 1 IN. = 5 FT.

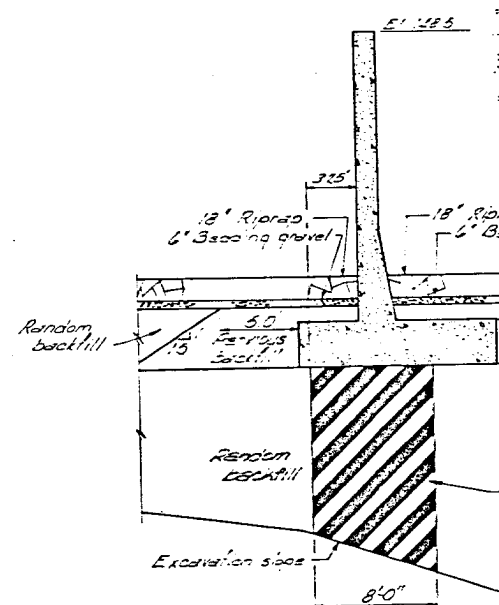
SECTION G-G

SCALE: 1 IN. = 5 FT.

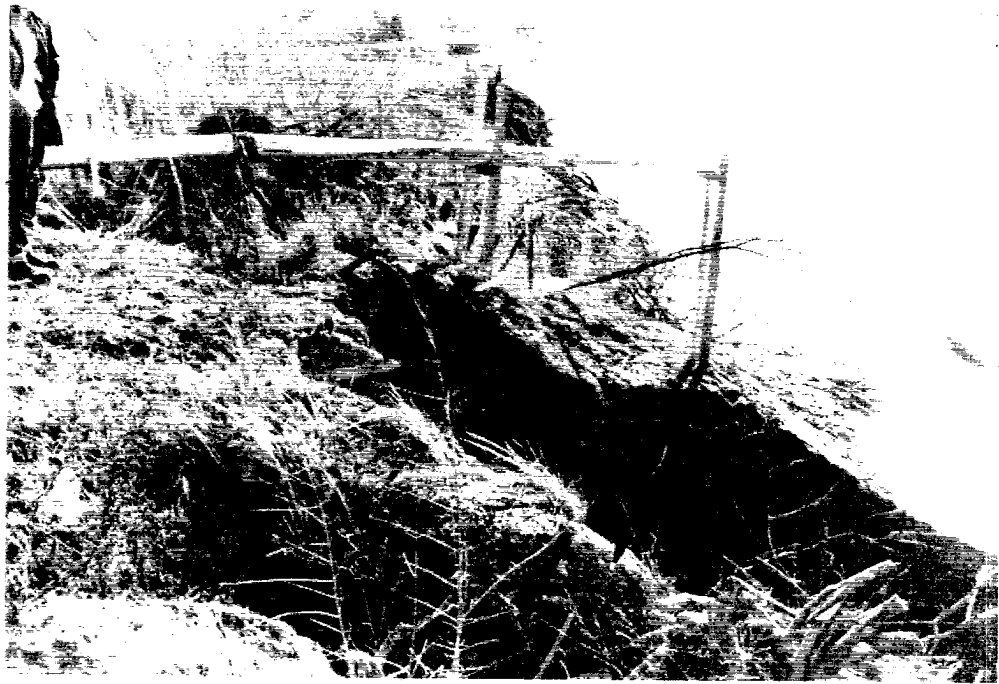
3. SLIDE AJACENT TO THE TALLAHACHIE RIVER

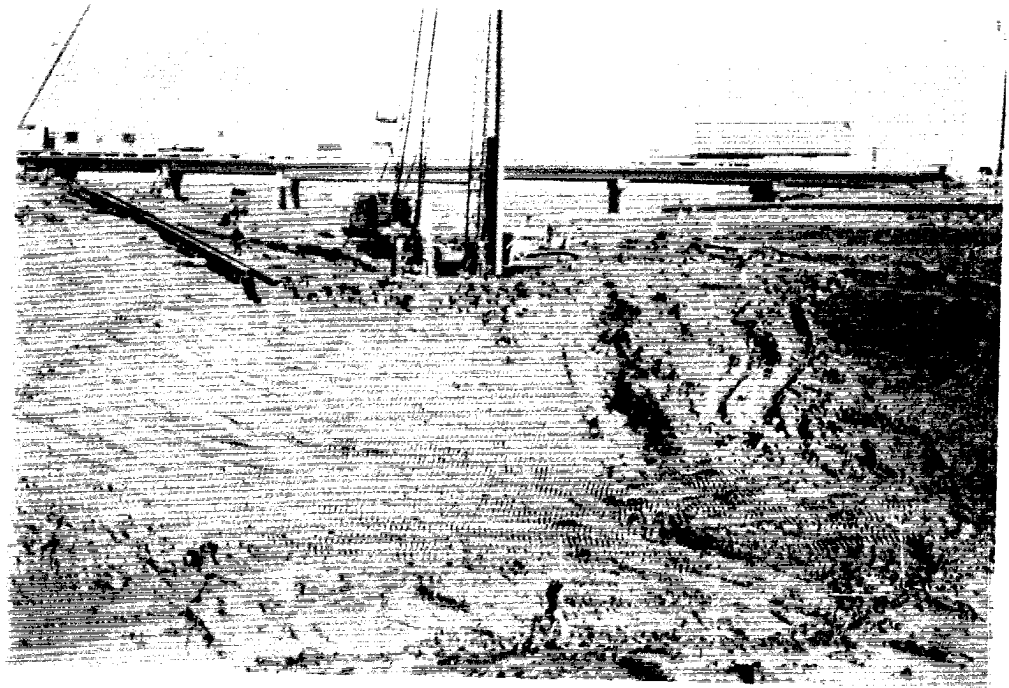
5. DRIVING TEST PILING BENEATH THE APPROACH MONOLITH

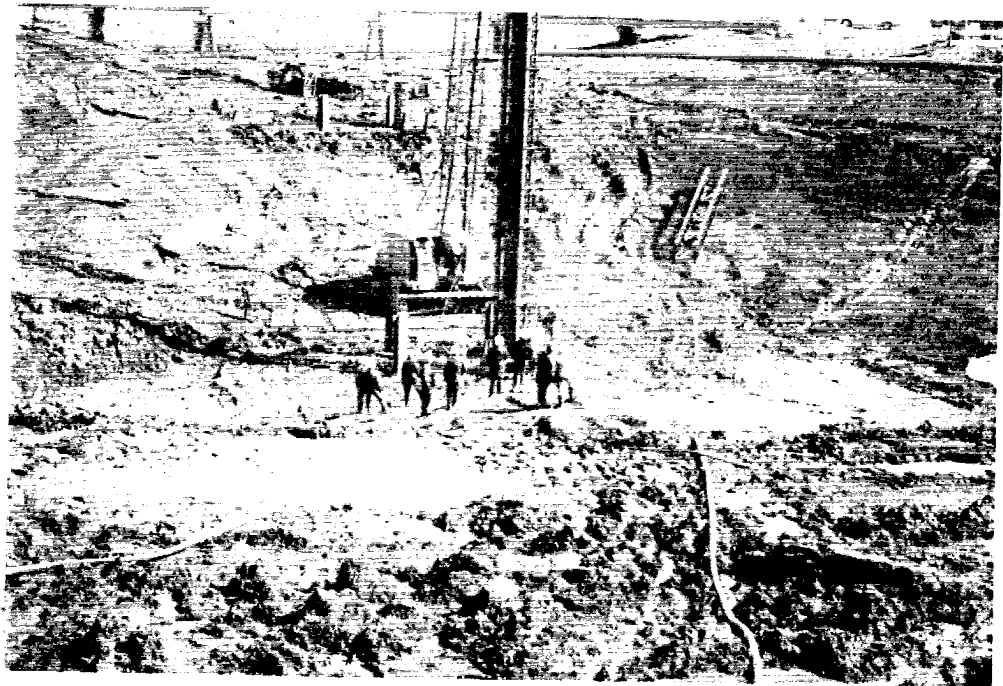
6. DRIVING TEST PILING BENEATH THE STILLING BASIN

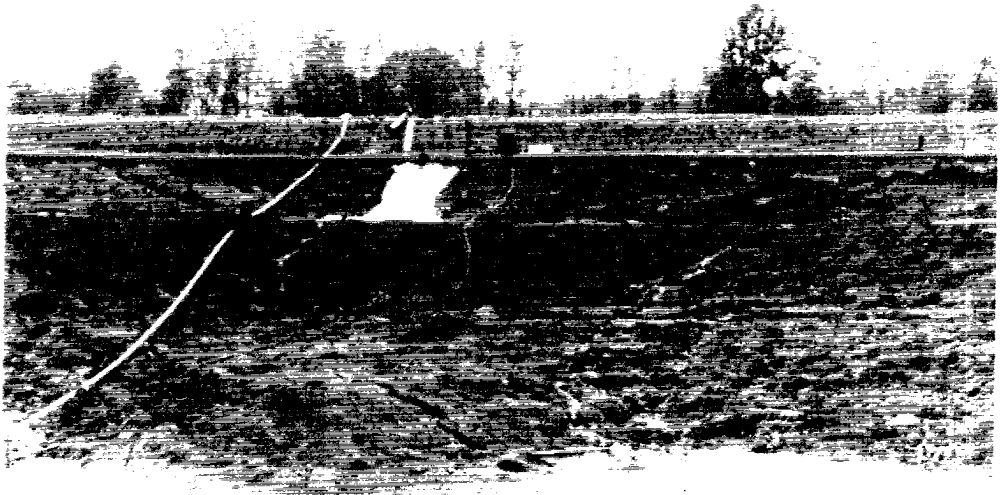
7. NORTH EXCAVATION SIDE SLOPE

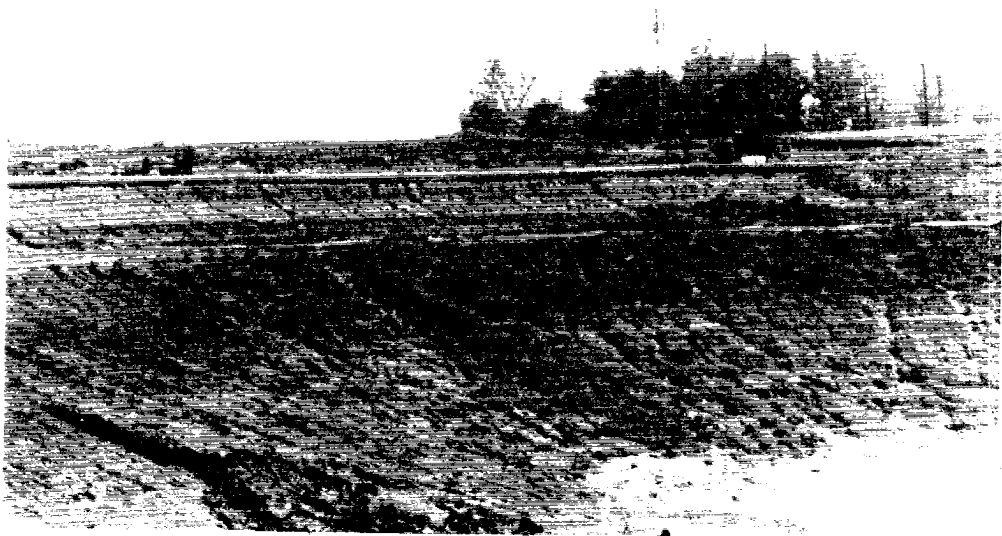
8. WEST EXCAVATION SIDE SLOPE

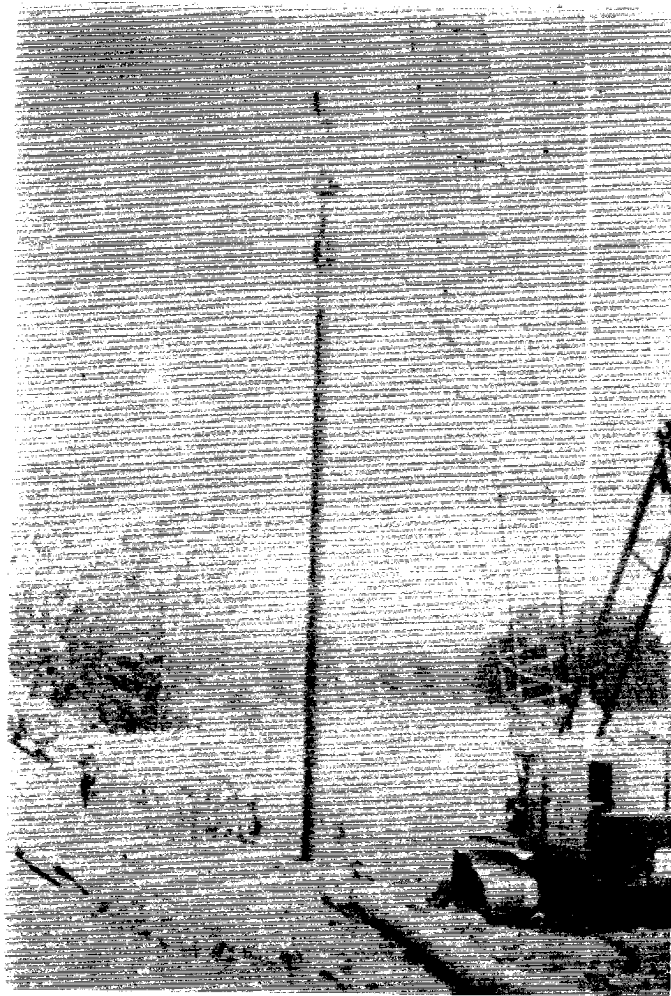
9. INSTALLATION OF DEWATERING WELL WITH JETTING TOOL.

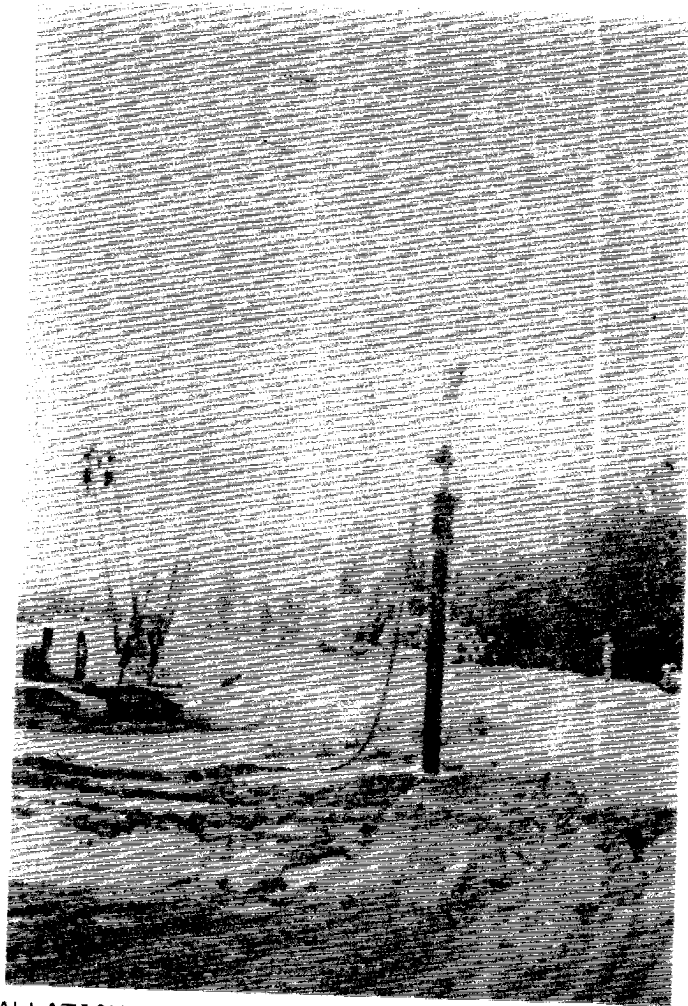
10. INSTALLATION OF DEWATERING WELL WITH JETTING TOOL

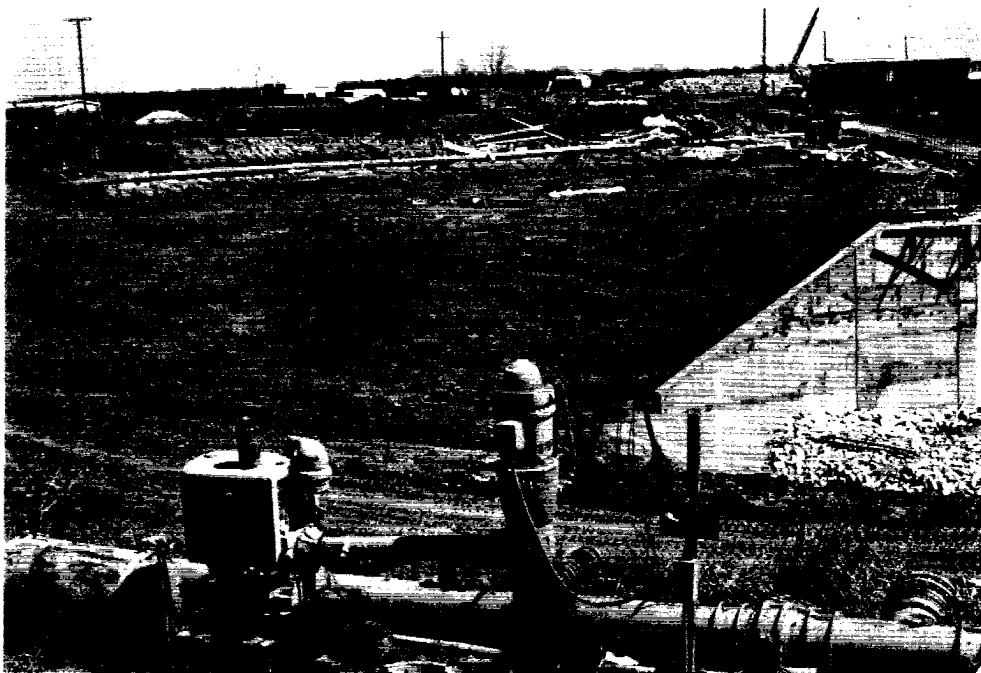
11. DEWATERING WELL #6, NOTE PRIMARY (ELECTRIC) AND BACKUP (DIESEL)

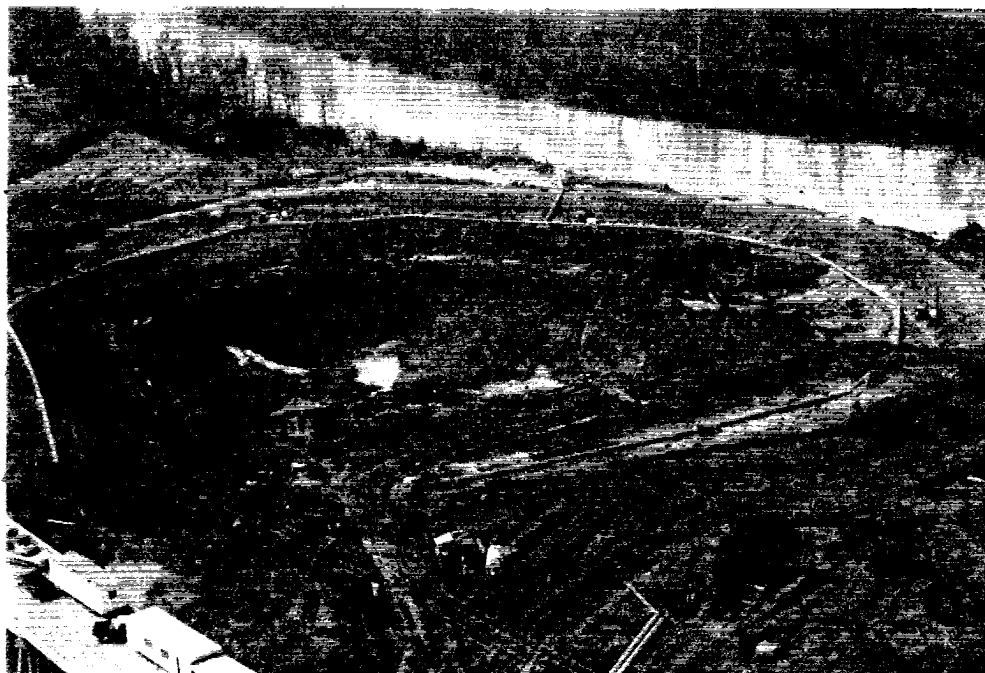
12. AERIAL VIEW OF DEWATERING SYSTEM

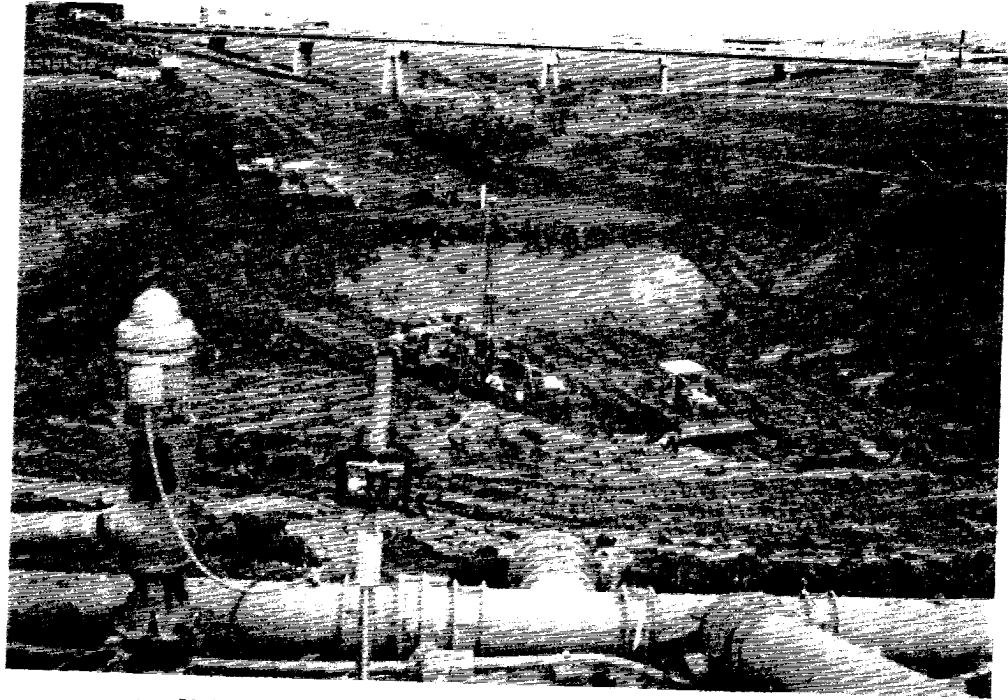
13. INSTALLATION OF CONSTRUCTION PIEZOMETER

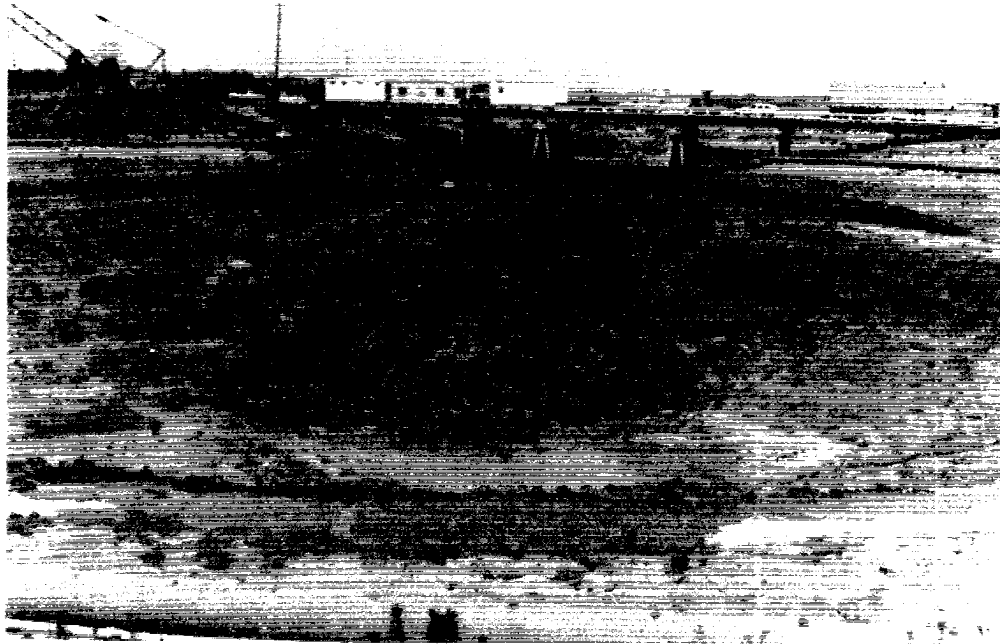
15. FIRST SLIDE-IMPERVIOUS BACKFILL

backfilling operation the impervious wedge failed along the backfill-excavation grade interface (Photographs 14 through 16). Investigations were performed by District and Greenwood Area Office personnel who concluded that the slide was a result of improper construction practices. The following construction methods are specifically noted as contributing factors:

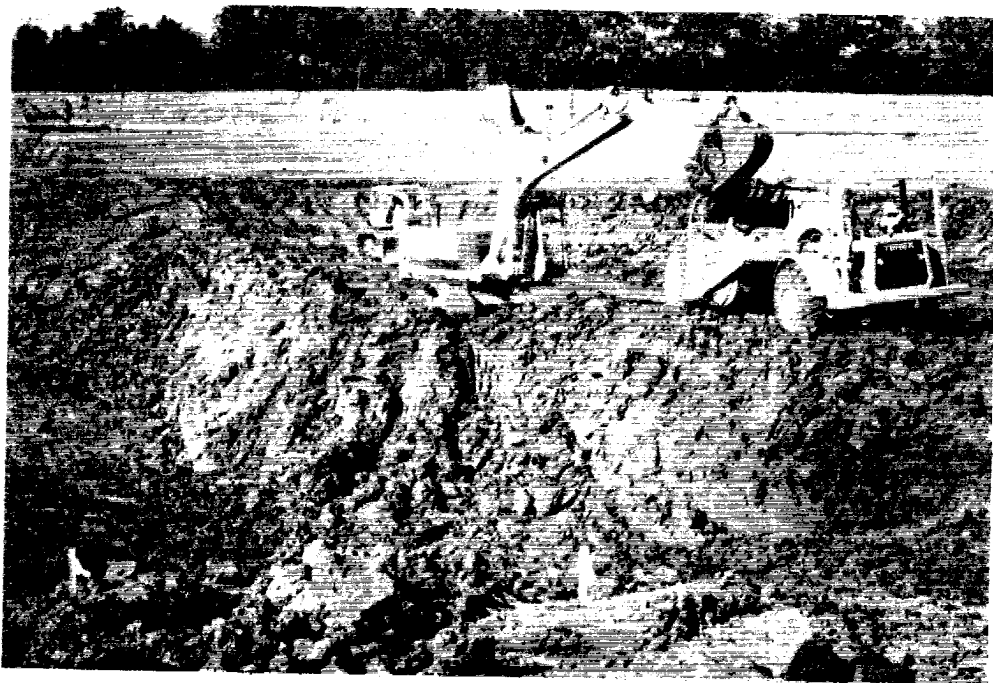
16. REMOVAL OF MATERIAL FROM IMPERVIOUS BACKFILL SLIDE

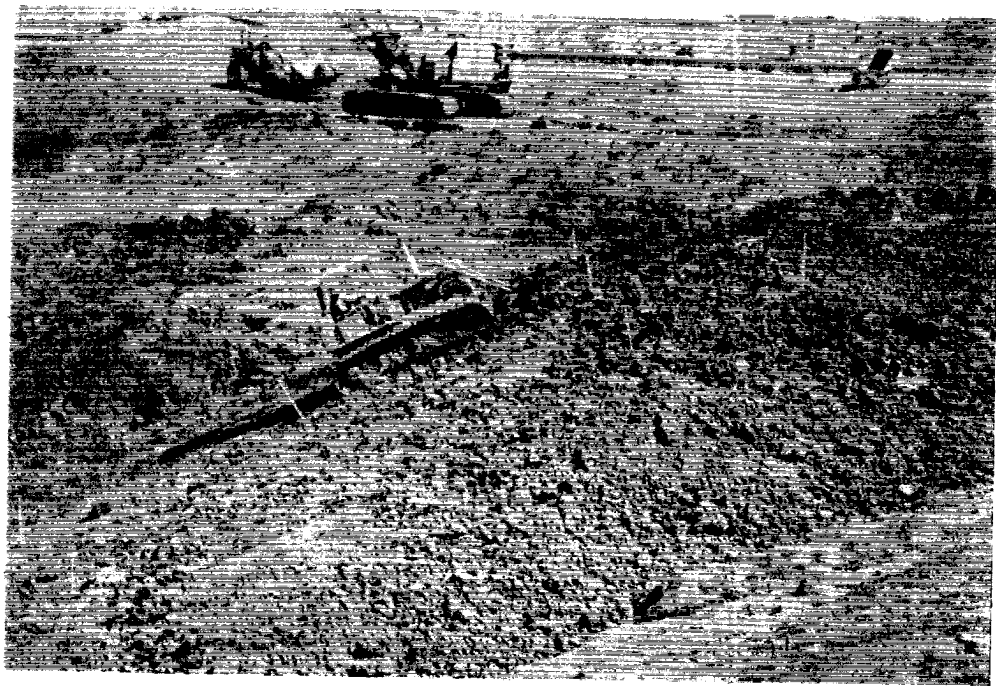
17. COMPACTING IMPERVIOUS BACKFILL NORMAL TO 1 ON 2 SLOPE

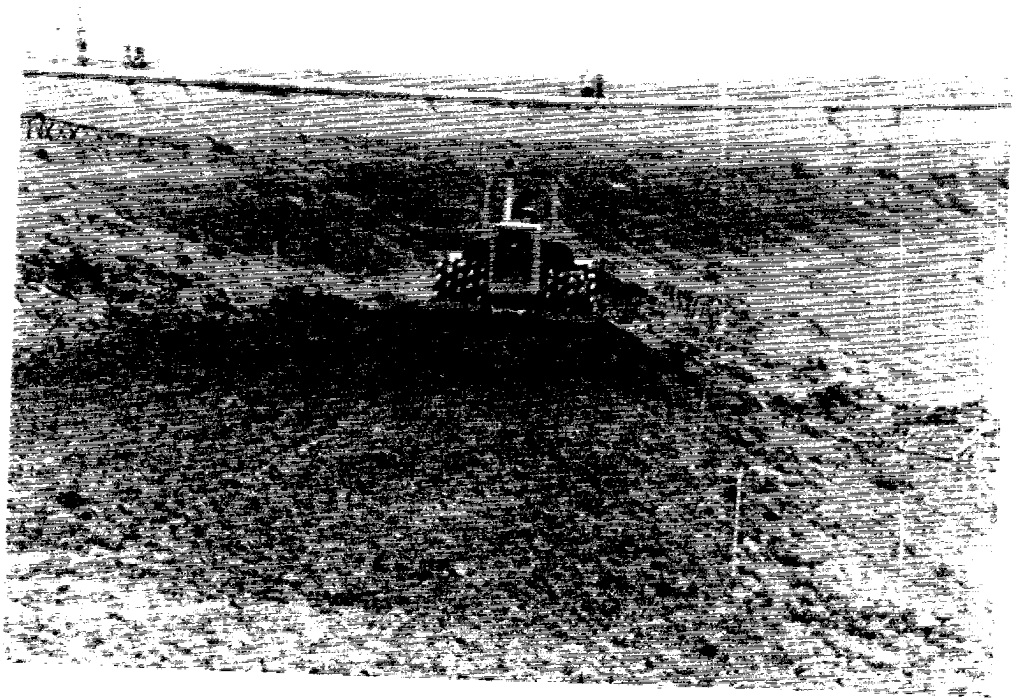
19. COMPACTING IMPERVIOUS BACKFILL IN HORIZONTAL LIFTS

The Contractor was instructed to repair the slide. The required 1-on-3 slope was reestablished, and the impervious backfill was placed as per contract specifications (Photographs 18 and 19). Unfortunately, no attempt was made to ensure that the failure surface was removed and the impervious backfill wedge failed a second time. Field investigations revealed that the

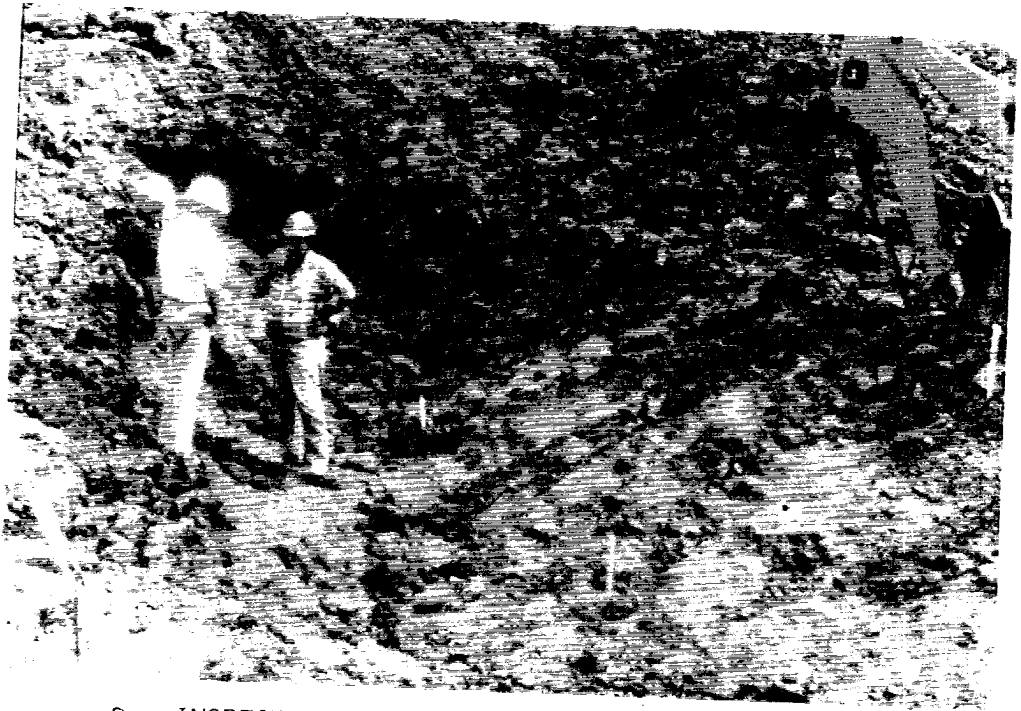
21. INSPECTION TRENCH-IMPERVIOUS BACKFILL

second slide resulted from movement on the original failure surface which had not been removed (Photographs 20 and 21). All disturbed material was then removed and the impervious fill was reconstructed as shown on Plate 13. No further problems were encountered.

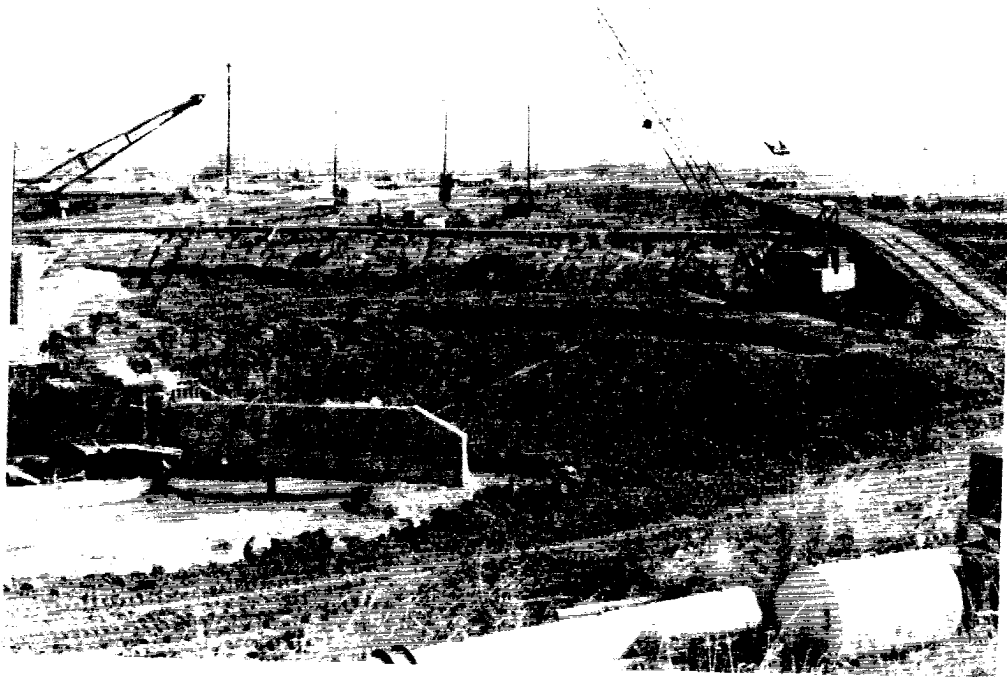
22. SLIDE IN RANDOM BACKFILL MATERIAL
